## MEMORANDUM

TO: Aramis Lopez, Jr. *AL* FILE: 800.12.8.9.13, 3202  
FROM: Srikanth S. Holikatti and Douglas J. Frith  
DATE: October 1, 1997  
SUBJECT: Suspension of SMP Site Monitoring Activities, Site 320204

This memo will serve as the SMP Site Monitoring Activities Suspension Status Report for Site 320204(32SB) near Battle Mountain, Nevada.

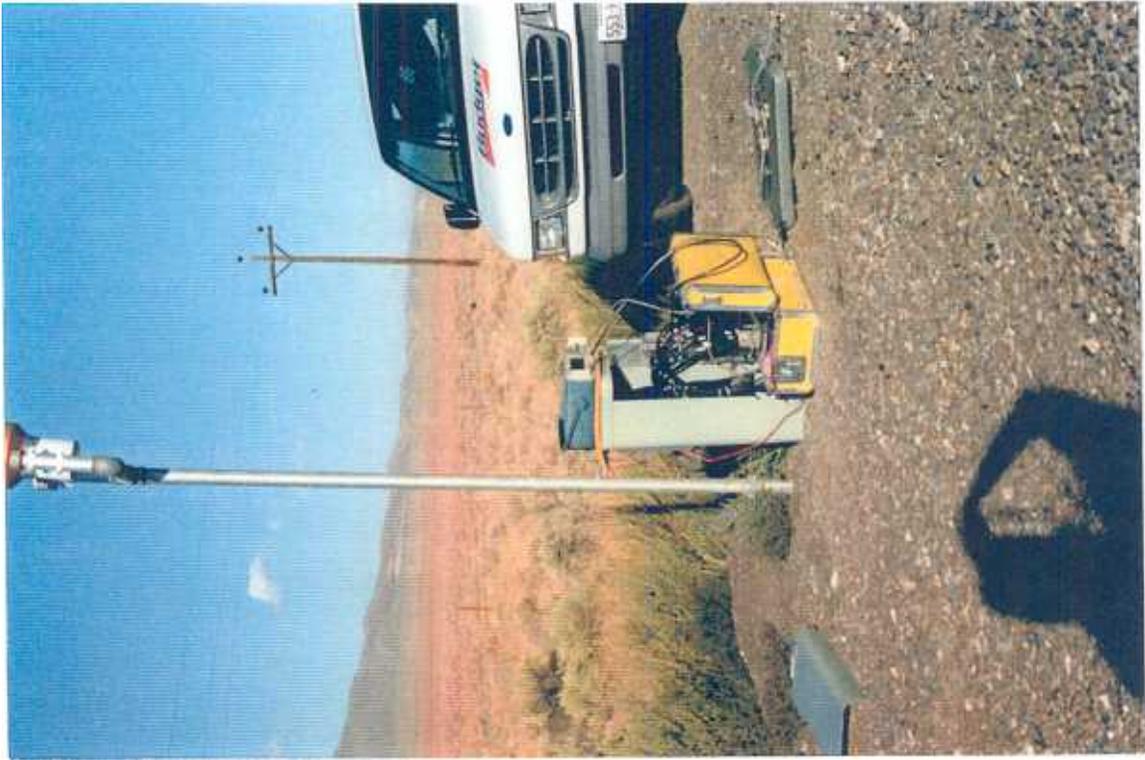
Photo Last set of data collection in progress

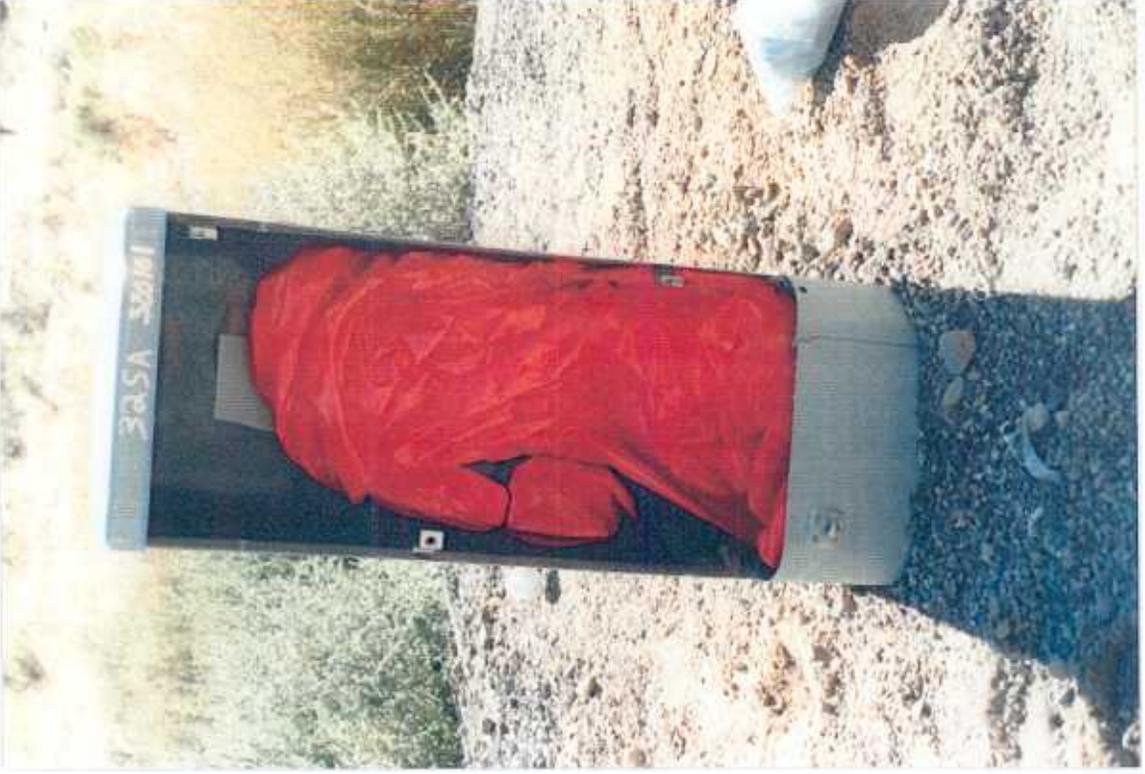
Photo Tied taped cable ends in the instrumentation box

- All TDR and other sensor cables in the instrument box were re-labeled, and the ends cleaned and electronic grade anti-corrosive compound was applied. The cable ends were organized in a logical manner, placed in a plastic bag, and taped with a bag of silica desiccant to keep them dry.

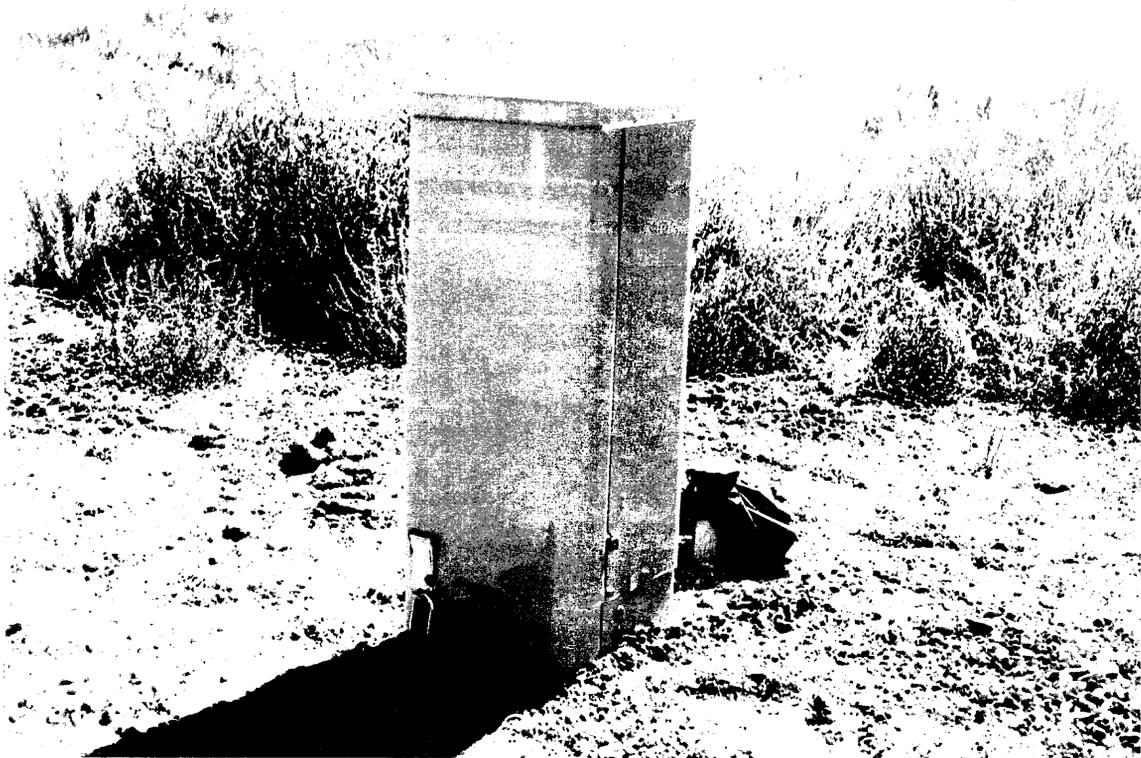
Photo 4. The instrumented area after dismantle.

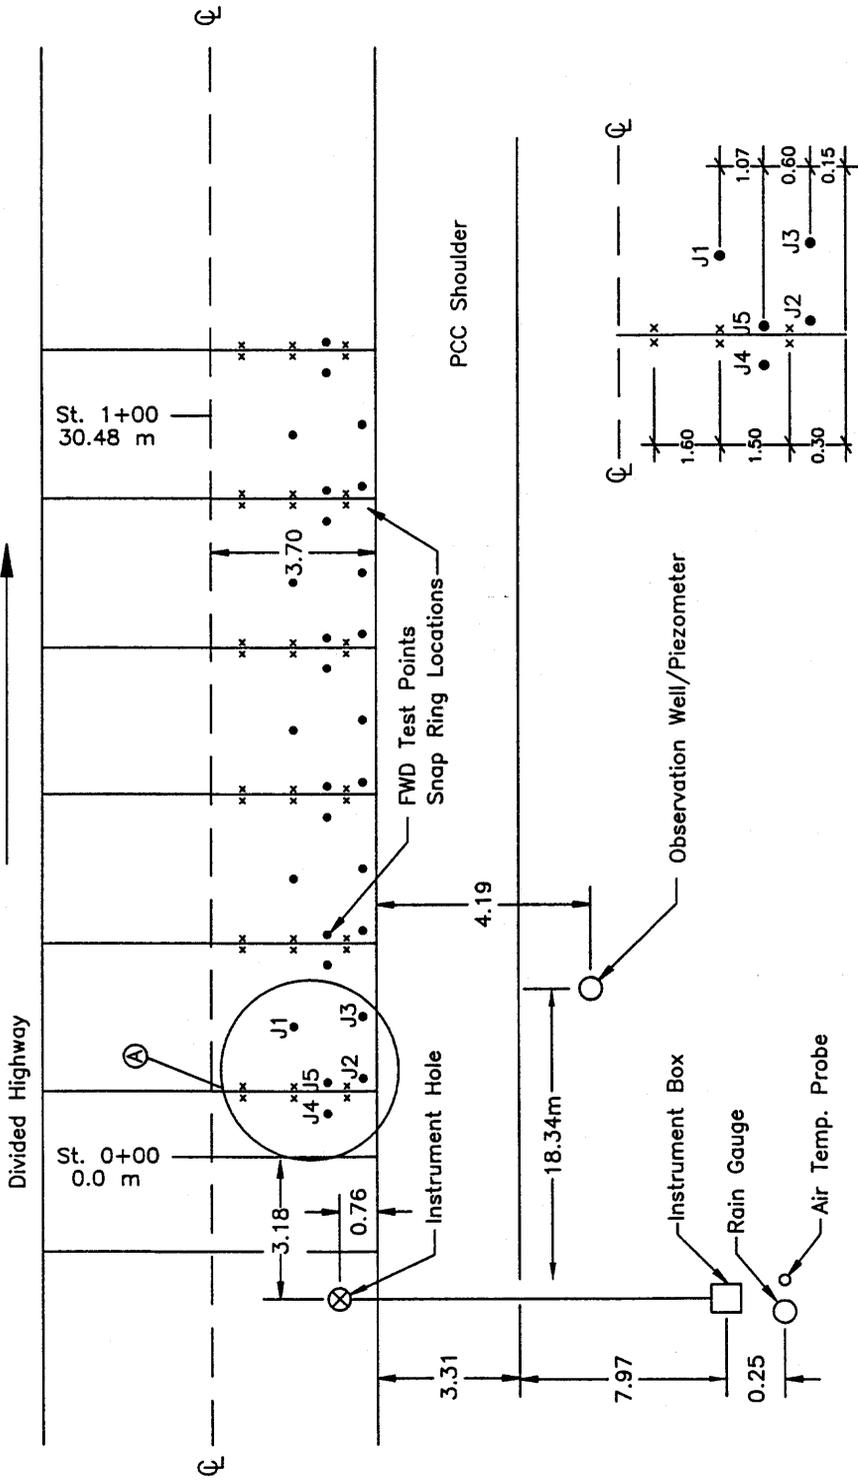
SECTION 320204  
Battle Mt., NV

The instrumentation hole is located 3.18m prior to the start of the section and the instrument box is located at a distance of 7.97m from the shoulder edge. The piezometer is located at 18.34m beyond the start of the section at an offset of 4.19m. Please refer to the enclosed layout schematic

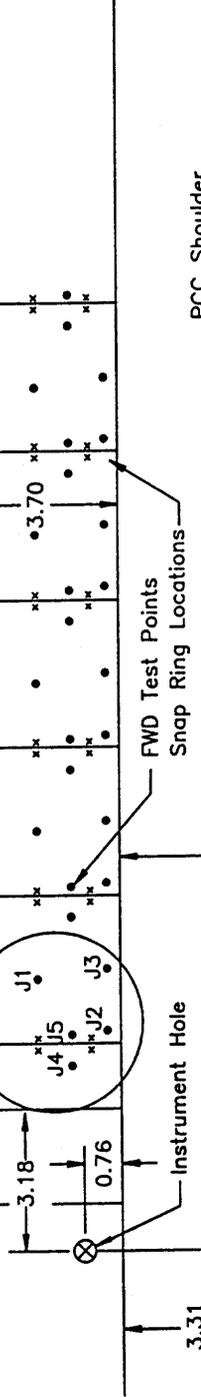
SECTION 320204  
Battle Mt., NV

PCC Shoulder

FWD Test Points  
Snap Ring Locations

Instrument Hole

Observation Well/Piezometer

Instrument Box

Rain Gauge

Air Temp. Probe

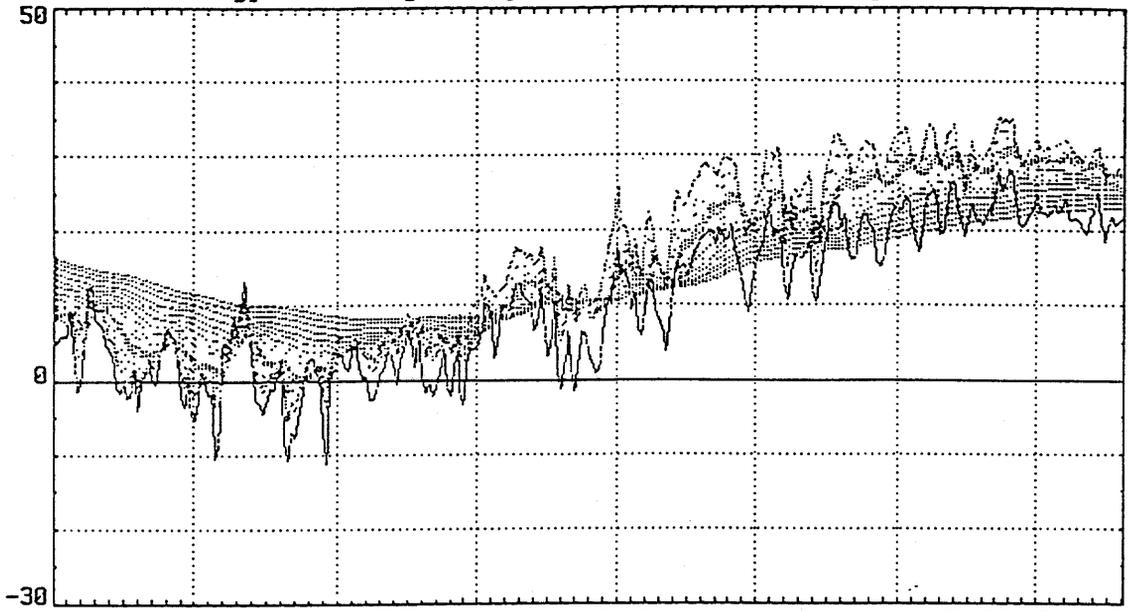
Nevada Site: B  
 Record Type 2 - Daily Average Air & 18 MRC Sensor Temperatures (°C)

314 (09/11/96) Day Number (08/09/97) 251  
 Legend: Avg. Air Temperature — First MRC Sensor Temperature —

Evaluation of data collected during the dismantle activities indicates that all installed instruments are functioning normally. There is no reason to believe otherwise at this site. Please refer to the enclosed SMPCheck plots.
